Scope Study Update

HOMESTEAD/WAKEFIELD ELEMENTARY SCHOOL

HARFORD COUNTY PUBLIC SCHOOLS
February 22, 2021

BANTA CAMPBELL ARCHITECTS, INC.

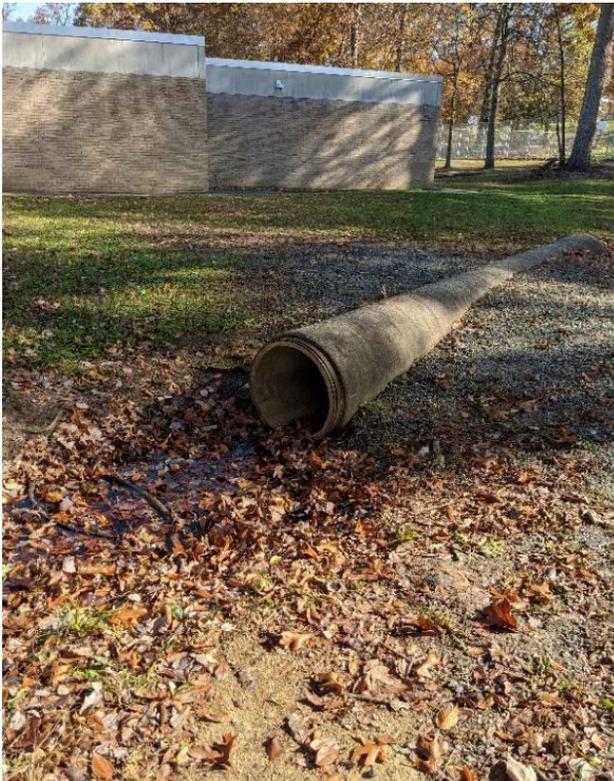
Typical Culvert Pipe lacking cover

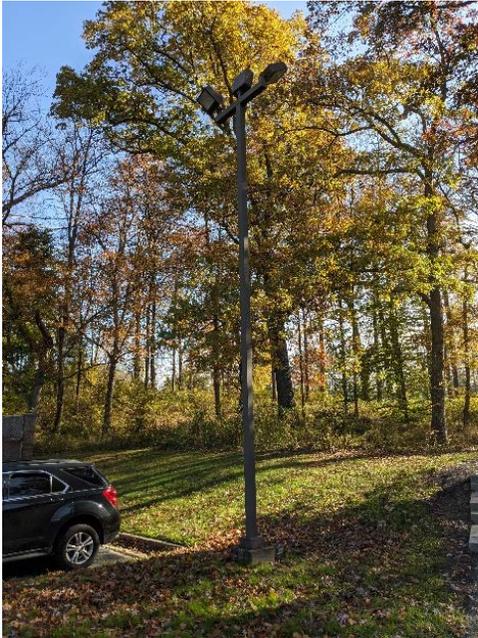
Site Lighting

Site lighting is a primary security consideration, and for this property, there is a limited amount of site lighting throughout the site. Mainly provided within the parking areas. It is recommended that site lighting be provided throughout the site to increase visibility and site security. Security cameras are visibly mounted on multiple locations on the school buildings. It is recommended these cameras be maintained or a new security system installed as part of the proposed development.

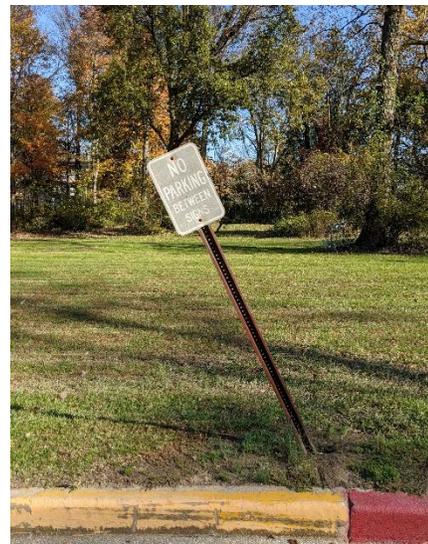
Signage Requiring Replacement

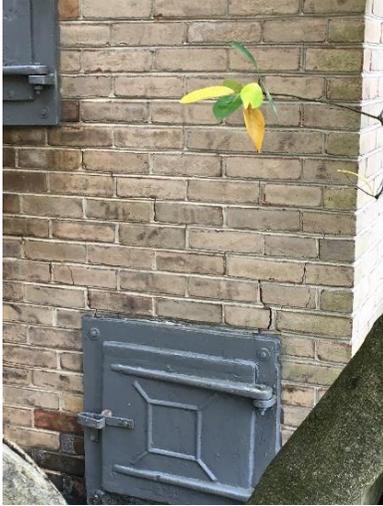
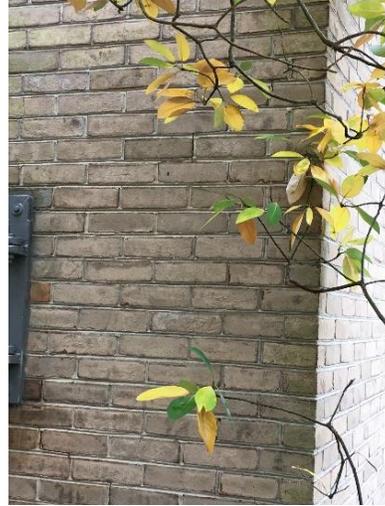
- Cracked masonry at the walls of the boiler stack. These propagate from the corners of the steel access doors. The cracks are probably due to a combination of minor settlement and thermal expansion.

The damage observed during the inspection is mostly due to water infiltration and long term exposure to the elements. The damage has not caused major structural issues but if left unattended will lead to expensive structural repairs.

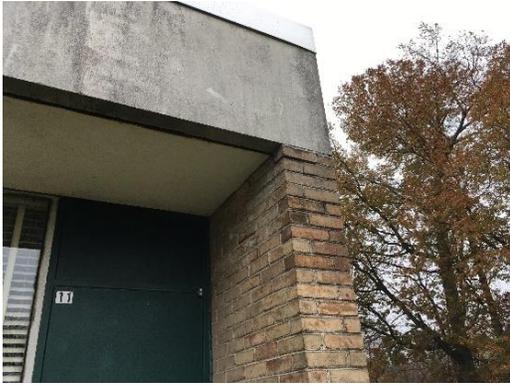
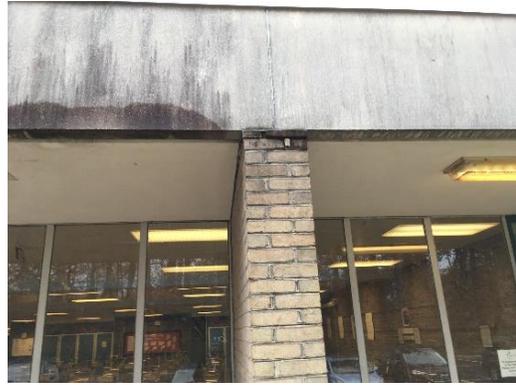
- There are a couple of loose bricks over top of piers at the cafeteria. This is probably due to thermal expansion of the steel members that bear on the masonry piers.

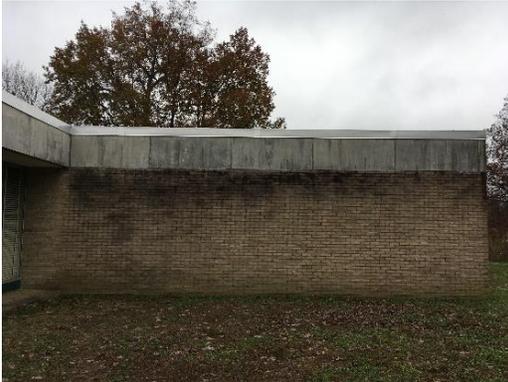
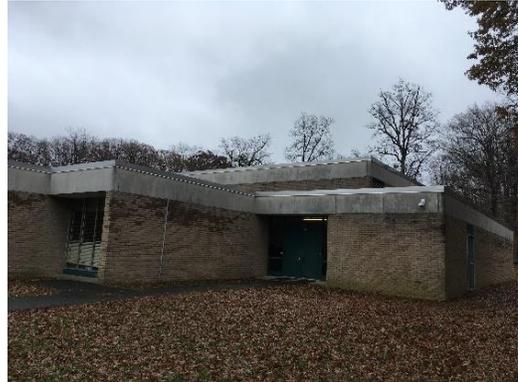
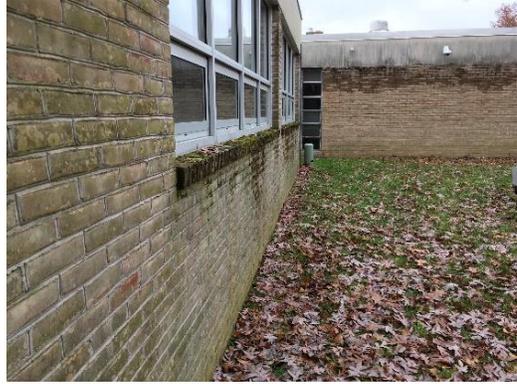
- Typically, there are signs of moisture along the upper sections of most of the exterior walls. The cause of the moisture is unknown, but it could be from water spilling over from the roof.

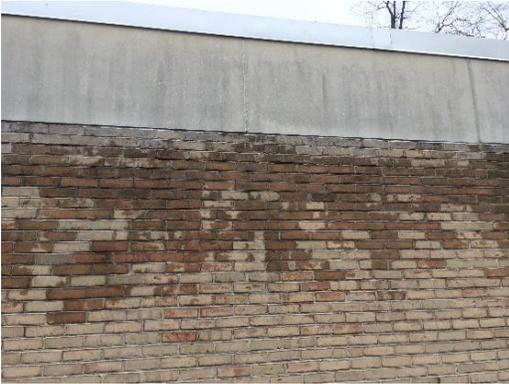
- Damaged and eroded brick joints was noted especially at the top sections of the wall where there is evidence of moisture. The constant moisture has probably softened and has caused the joints to deteriorate.

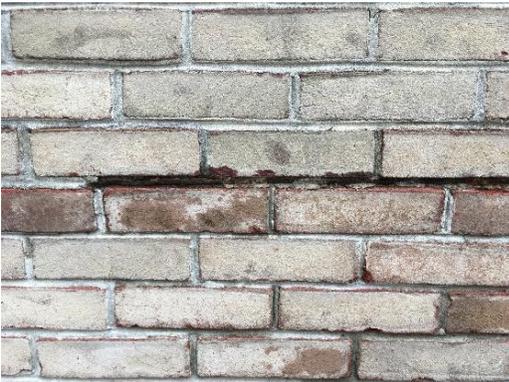
- Some joints have exposed horizontal reinforcing that has begun to rust. This is probably due to the moisture issue. The rusting action causes the reinforcing to expand and crack the mortar in the joints.

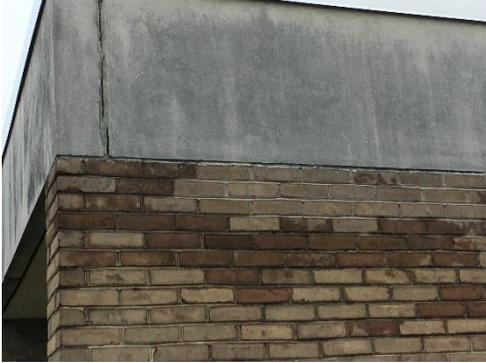
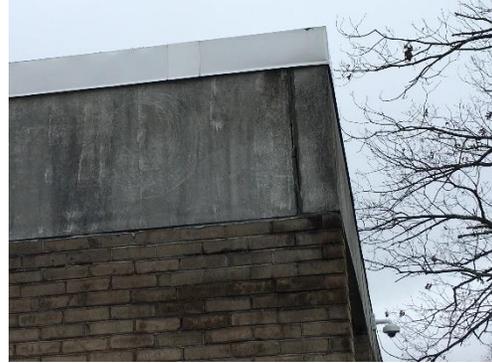
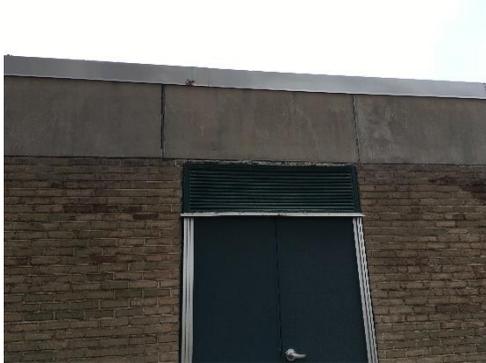
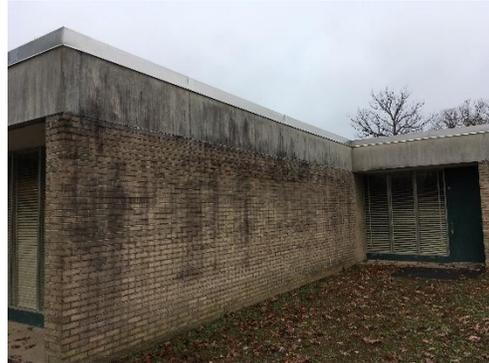
- Cracked, damaged and open caulk joints at the vertical joints between the panels and at the bottom of the panels. The caulk appears to have reached its useful life.

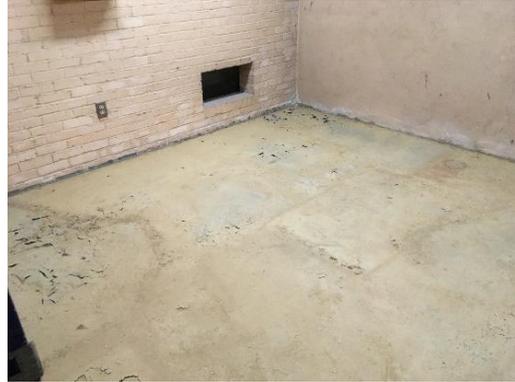
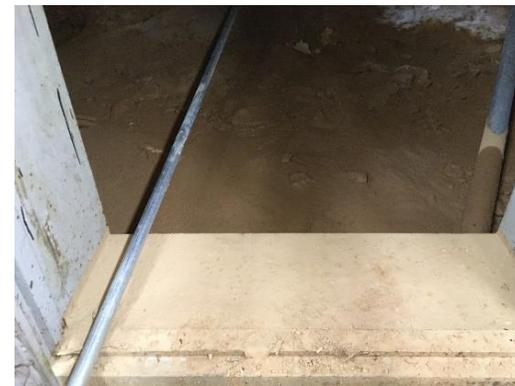
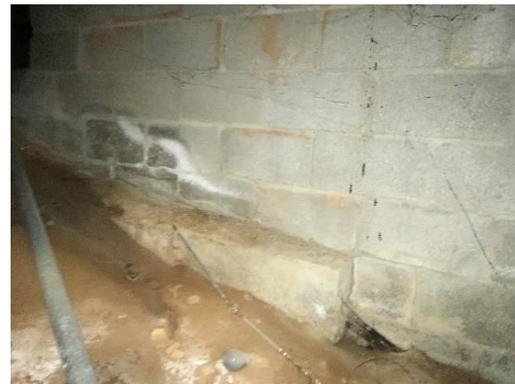
- Dried soil residue was noted against the north wall of the main mechanical room, at the upper mechanical rooms and especially at the room that provides access to the mechanical crawl space. The soil inside the crawl space was found to be wet, saturated and there were signs of water infiltration into the crawl space. It appears that water is seeping thru the exterior wall of the crawl space and that the water is then overflowing into the main mechanical room and draining into one of the floor drains of the mechanical room

The damage observed during the inspection is due to water infiltration, long term exposure to water and the elements and due to minor settlement. The damage noted has not caused major structural issues but if left unattended will lead to expensive structural repairs.

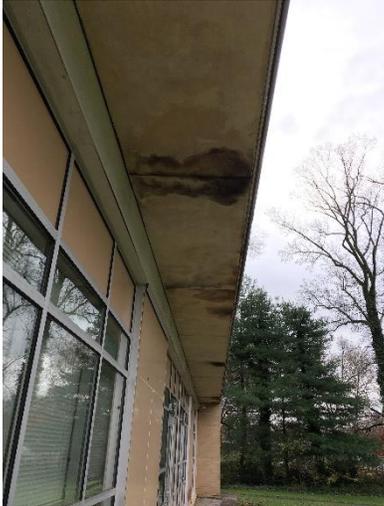
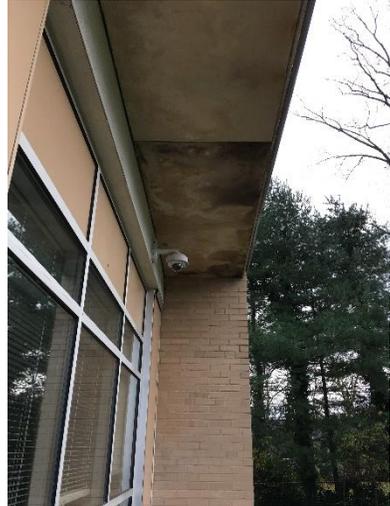
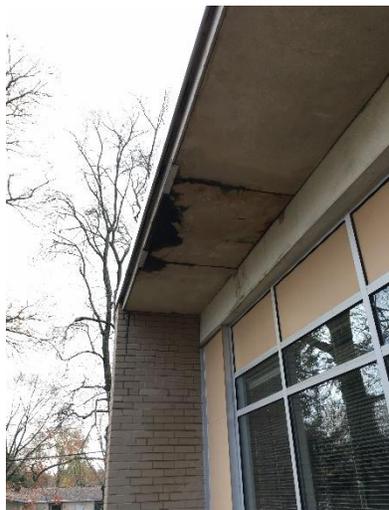
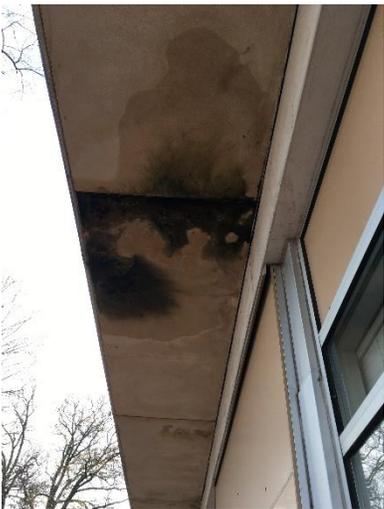
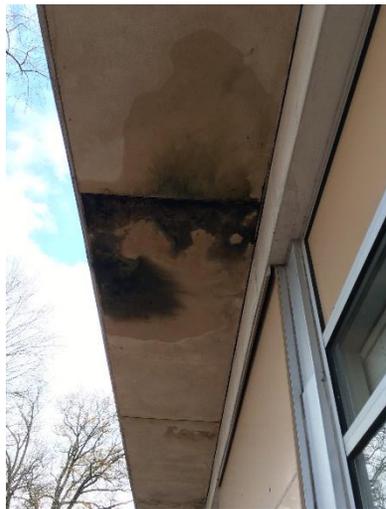
- Water from the roof is spilling over the edge especially at the continuous roof overhangs. The water has soaked the soffits at numerous sections of the overhangs. The constant moisture appears to be causing the growth of mold.

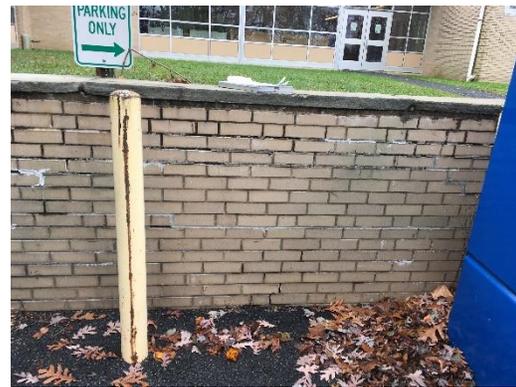
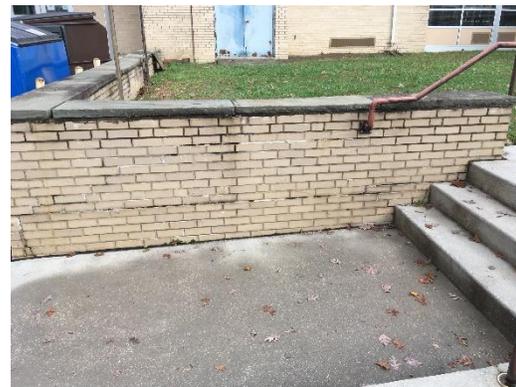
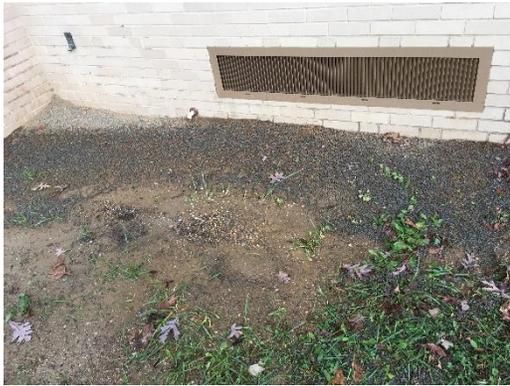
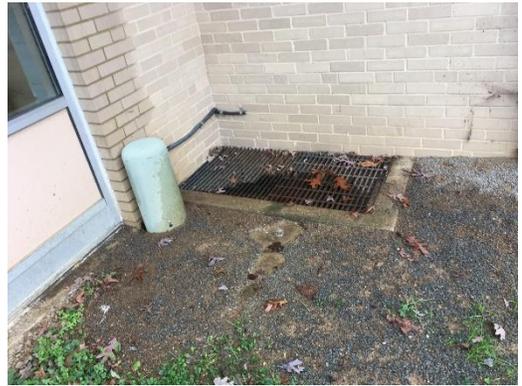
- Cracked exterior walls at the loading dock probably due to settlement. The adjacent loading dock walls and slab have been damaged and severely cracked. The adjacent site walls are cracked and damaged.

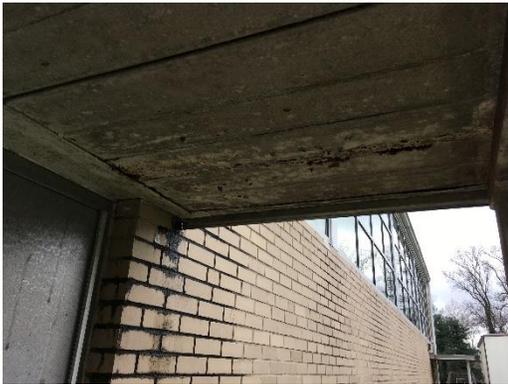
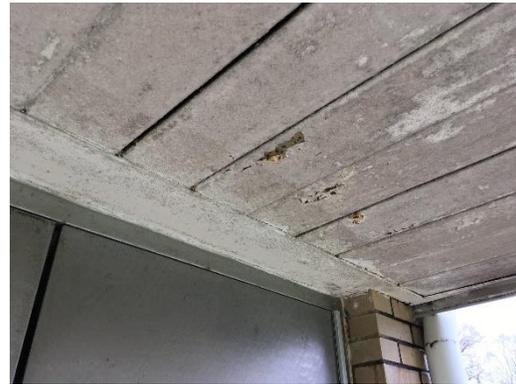
- Rust damage to the metal deck at the small entrance canopies over the exterior doors to the multipurpose room. The rust in some cases has come thru the metal deck.
