William Paca / Old Post Road Elementary School

## Scope Study

July 6, 2009

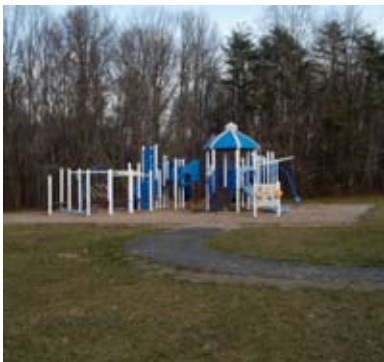
Site Fig. G

A 60' diamond is located between the school buildings along with a playground area and an additional hard court play surface. Another playground area exists on the eastern side of the Old Post Elementary building. The baseball diamond, hard court play surface, and playground areas are in good condition (Site Fig. G).

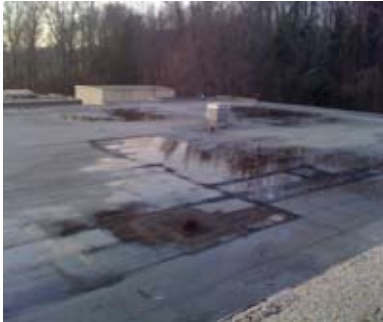
OPR Fig. A

The roof is a combination of sheet membrane and asphalt built-up roof with ballast stone over a flat roof deck. Both roof membranes show signs of recent repair. The sheet membrane show signs of blistering and ponding. Openings, including skylights, drain vents, roof drains and through the roof penetrations, appear in good condition. There is a mix of roof drains and gutters. Gutters appear to have been added to accommodate the lack of overflow drains in the original design. The fascia and roof edging are in good condition. The flashing appears to be in good condition however the staff had indicated roof leaks that were not observed at time of report survey (OPR Fig. A).

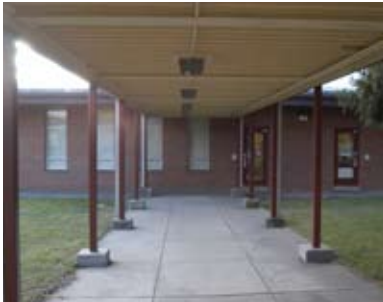
OPR Fig. B

The exterior is an uninsulated composite brick with CMU backup. The masonry and mortar appear in good condition; however repointing at about 10 percent of the walls is recommended. Flashing and weeps appear to be performing properly.

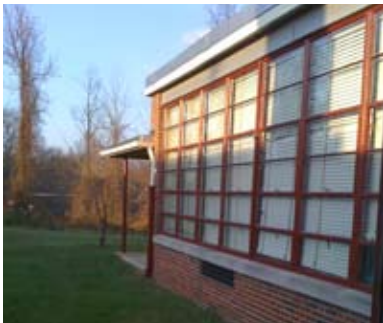
OPR Fig. C

The windows are an uninsulated single pane metal frame system. Windows appear to be original and show sign of only minor repair over life of the window. For increased thermal performance and energy reduction these windows could be replaced (OPR Fig. C).

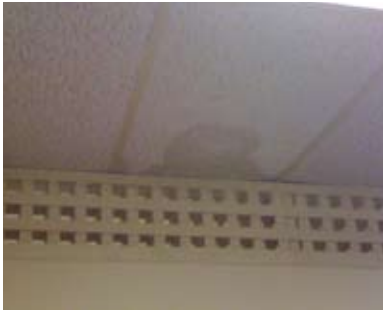
OPR Fig. D

Typically, the finished ceiling is a suspended 2x4 acoustic panel and grid system. The panels are stained due to water damage, bowed, discolored and should be replaced with a suitable material (OPR Fig. D). There is a hard ceiling in the kitchen which is in good condition.

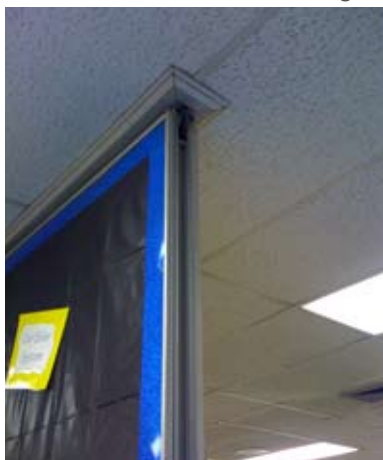
OPR Fig. E

Interior partitions are typically painted CMU. There are some movable interior partitions between classrooms that are unused and provide poor acoustic barriers (OPR Fig. E). Most partitioning is in good condition, but requires patching and painting. Folding partitions that separate the gymnasium and cafeteria appear to be in good condition but are difficult to move.

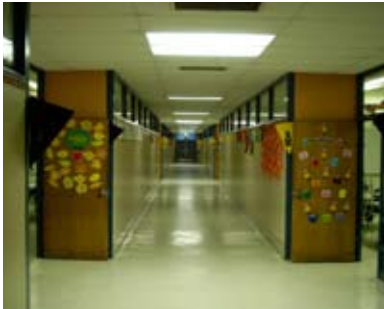
WP Fig. D

Interior partitions are typically painted CMU, the partitions along the classroom corridors are stud infill with drywall facing (WP Fig. D). Most partitioning is in good condition, but requires patching and painting.

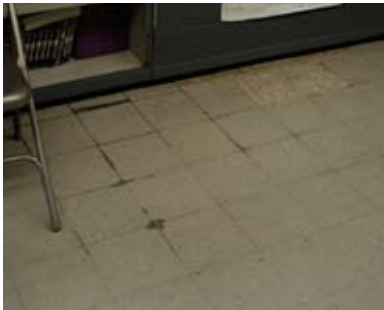
WP Fig. E

Corridor, restroom area and kitchen floors are ceramic tile. Other rooms are typically asbestos tiles or VCT tiles and should be replaced (WP Fig. E). The media center has carpeting. All typical flooring is in good condition. The stage floor is wood and is in need of reconditioning. The gym floor is VCT and should be reconditioned.

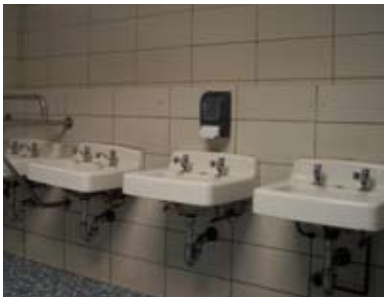
WP Fig. F

Restrooms are adequately sized but do not comply with ADAAG (WP Fig. F).

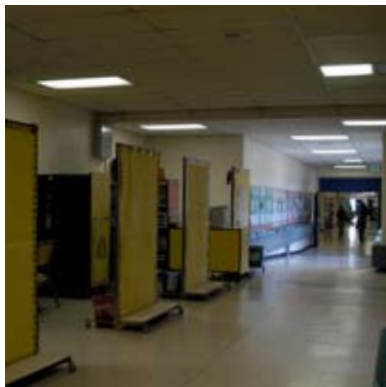
Classroom in corridor

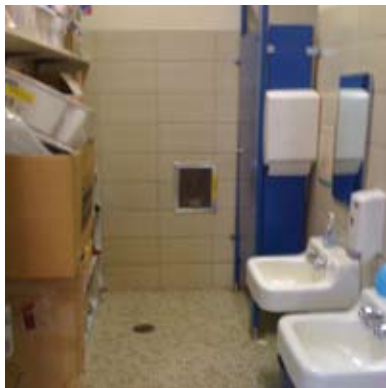
Storage overflow in restroom

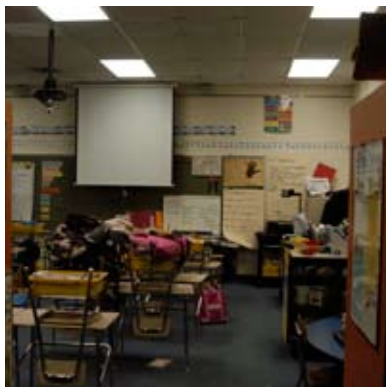
Classroom with no natural light
