Scope Study Report

Joppatowne High School

Harford County Public Schools

Banta Campbell Architects, Inc.

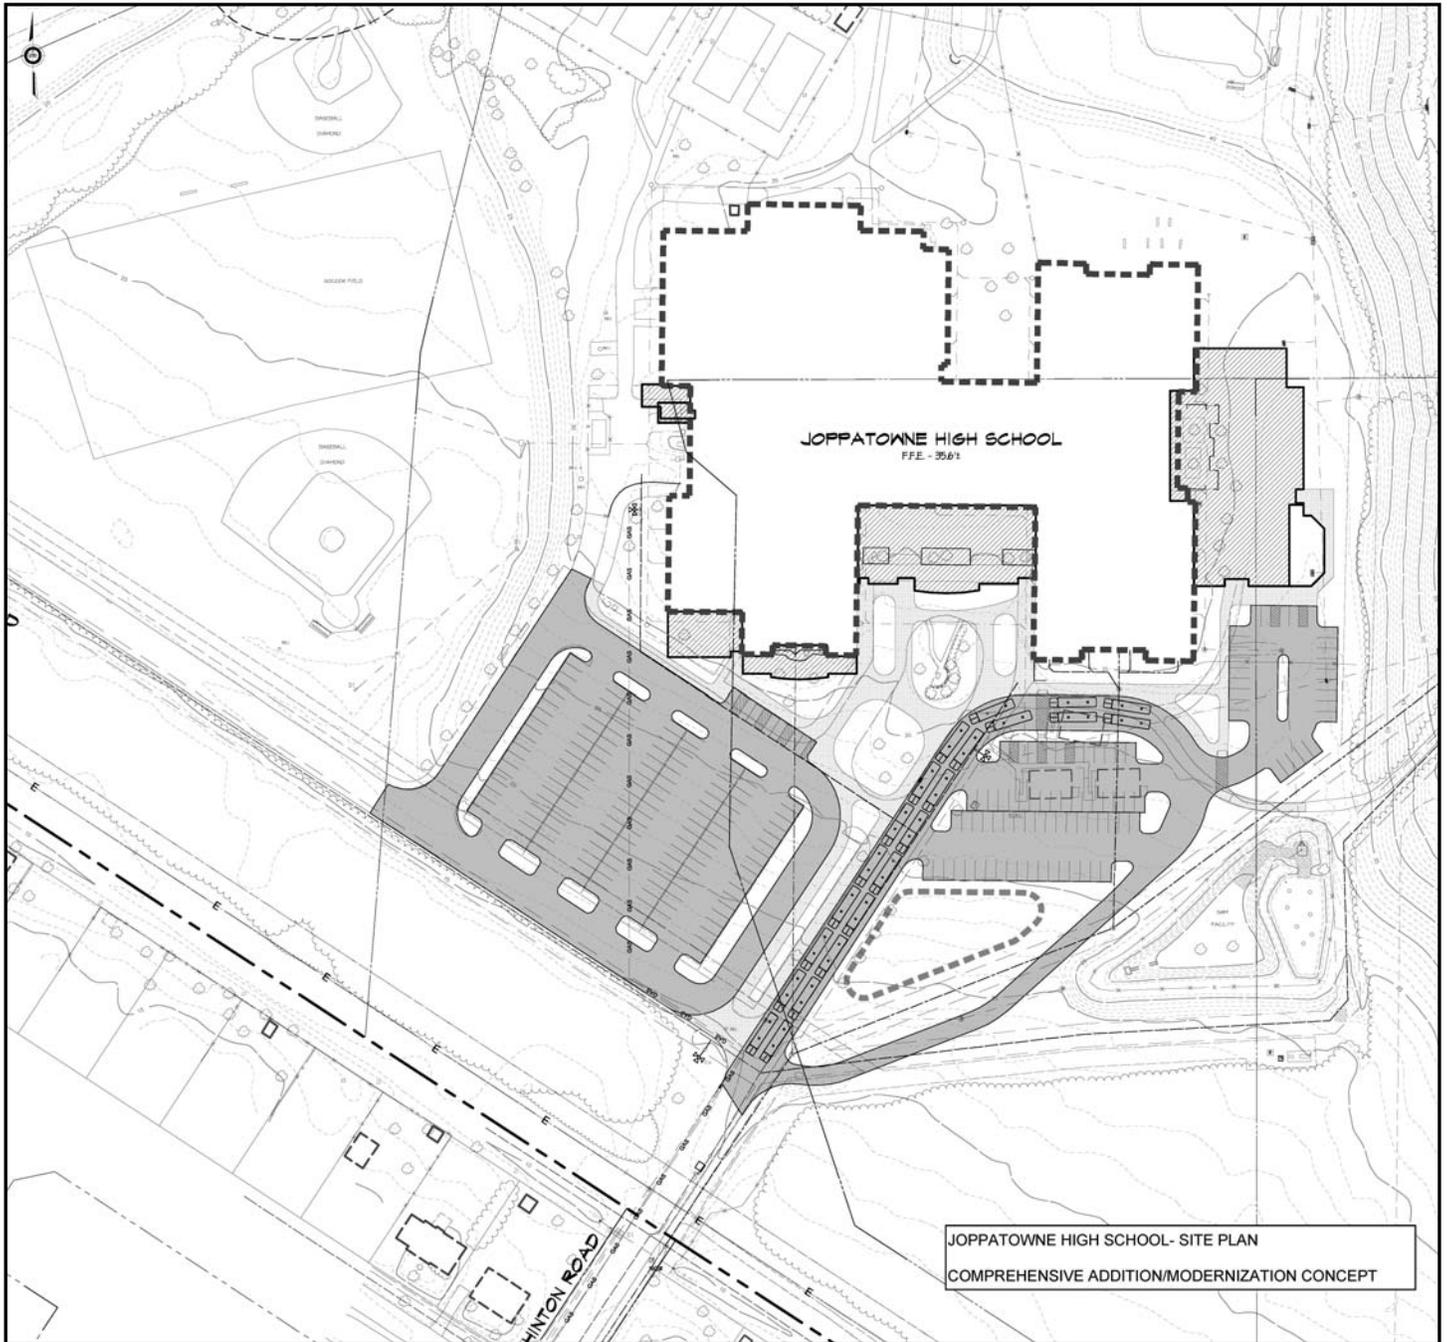
Joppatowne High School Comprehensive Addition/Modernization Concept Site Plan

The existing parking lot to the southwest will be resurfaced and reconfigured. Parking spaces will be striped to current standards. The revised drive configuration will provide student drop-off along the median between the bus loop and the main entry. Handicapped accessible parking will be expanded and provided adjacent to the building in two of three locations.

A “mountable curb” will be developed at the lower parking roadway and the Clinton Road bus loop. Essentially on a day-to-day basis, busses, staff, and visitors will use Clinton Road. Students driving and student drop-off will use the Falconer Road entrance. Emergency vehicles will be able to traverse the mountable curb.

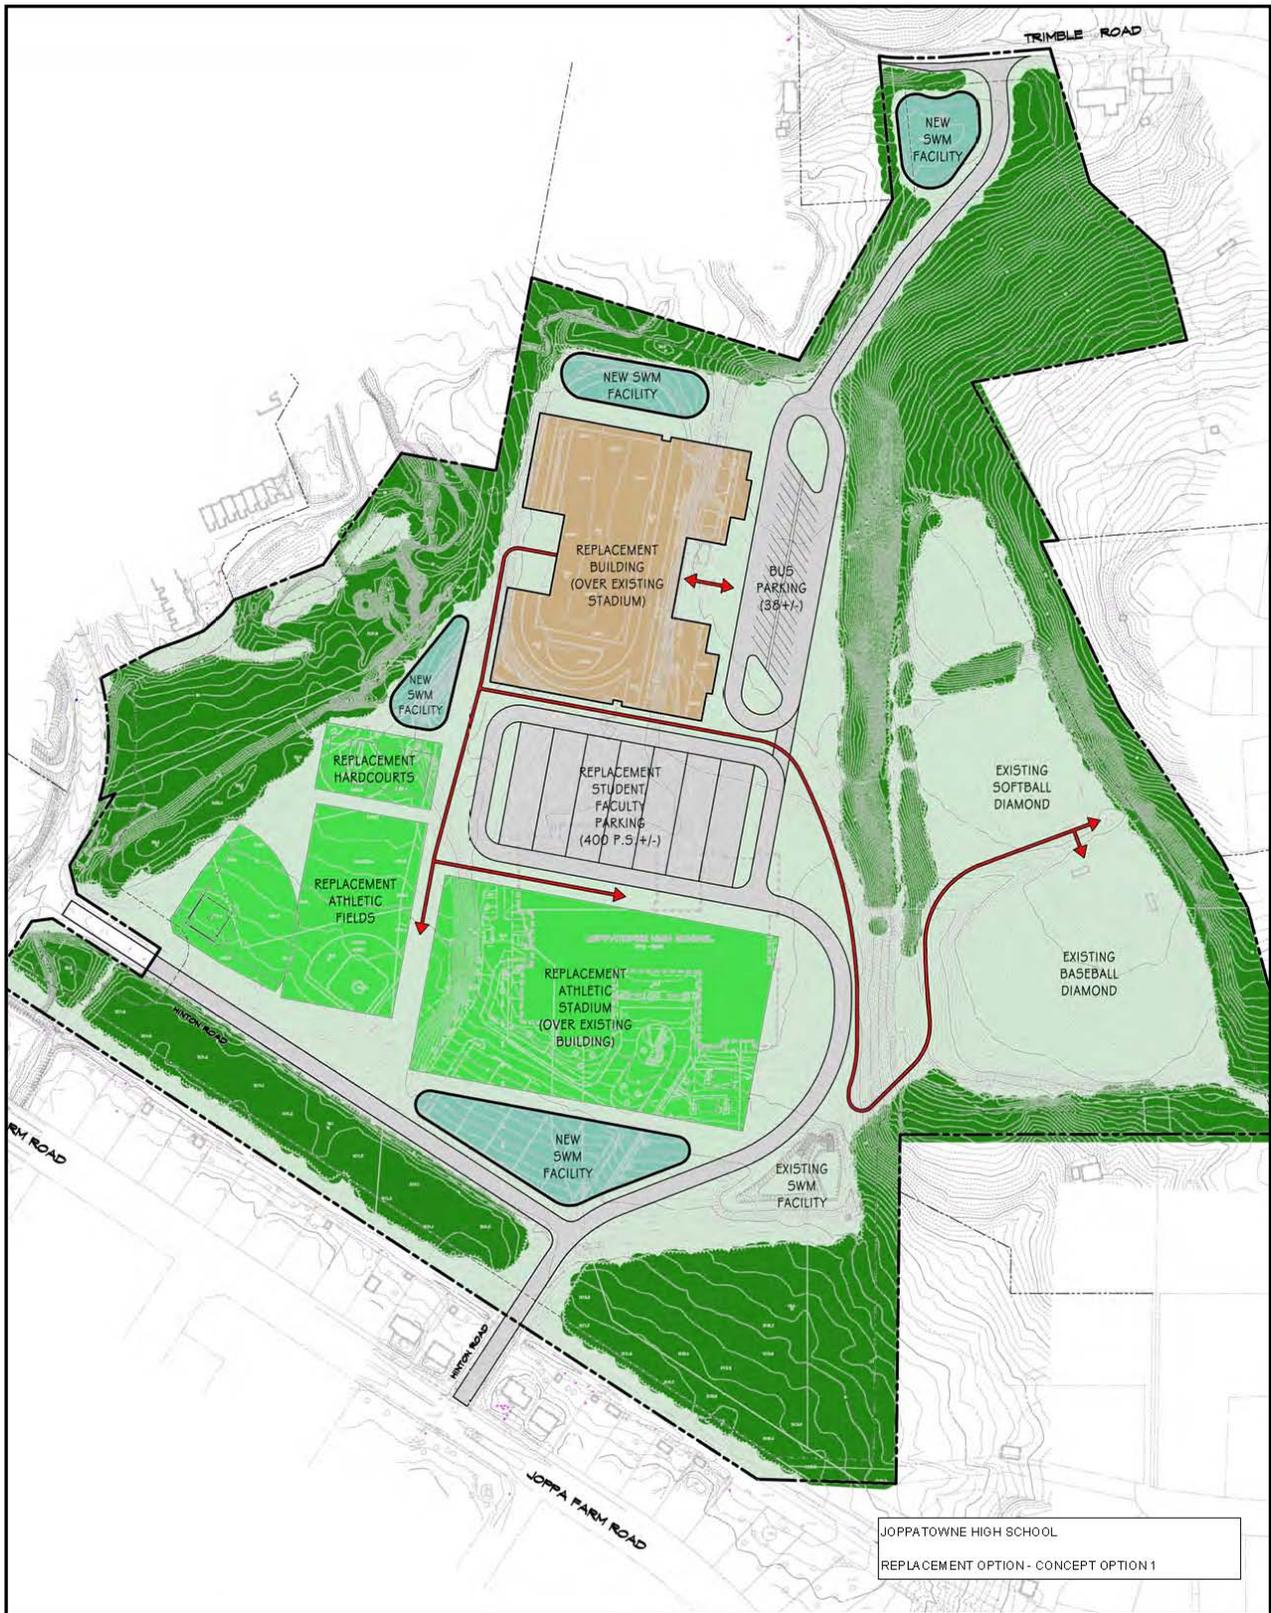
Joppatowne High School Replacement Concept Site Plan 1

1. The only reasonable location for a replacement building is on the site of the existing athletic stadium for reasons of drainage, size and maintaining continued occupancy of the current building through construction of the replacement.

2. The difficult topography on the existing site would cause for much more extensive earthwork and grading operations in order to construct the new building. The site would be disturbed to a far greater degree and may expose unknown issues regarding subsurface conditions such as rock or poor soil structural qualities. A proposed Trimble Road entrance would require some difficult grading as the northwest portion of the property where the road would be located is already at a 10% slope.

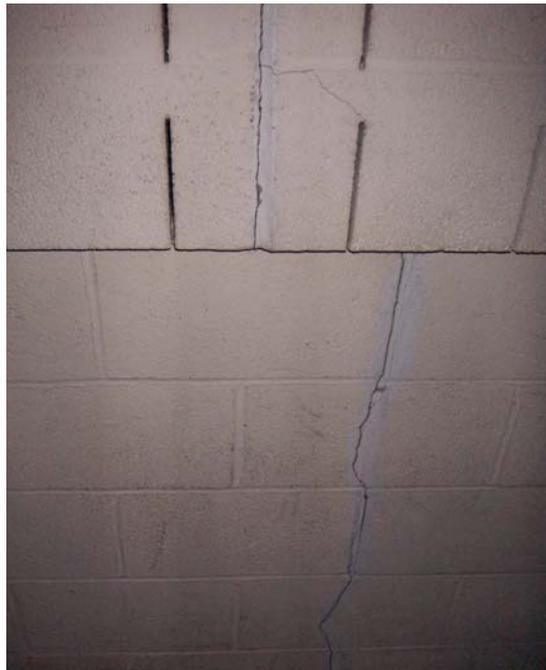
2. A vertical crack is present in both the east and west masonry wall of the auditorium. The crack starts at the slab on grade, and projects all the way to the top of the wall. CEI believes these cracks are related to the columns on line L (the cracks occur immediately adjacent to this column line). According to the plans, the columns on line L are blocked tight inside the masonry walls. Differential movement between the steel column and the masonry will propagate a crack in the wall. Incompatible coefficients of thermal expansion, and movement of the building frame under applied lateral load can both generate differential movement. The cracks do not appear to compromise the structural integrity of the wall. The cracks can be repaired, but as long as the column is enclosed in the wall, they will reappear over time.

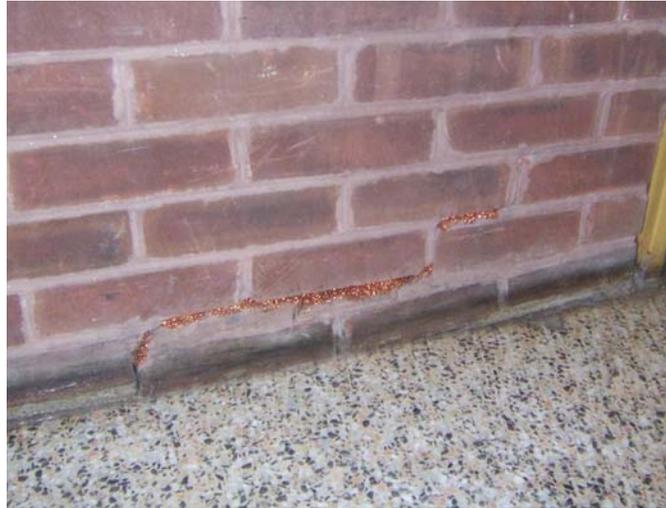
3. The slab on grade is settling around the wall separating the serving area from the cafeteria. Similar to the settlement occurring around the auditorium stage, the masonry walls in the cafeteria are supported directly on the slab (no footing), and the proximity to the nearby basement wall indicates that the supporting soil may be poorly compacted fill.

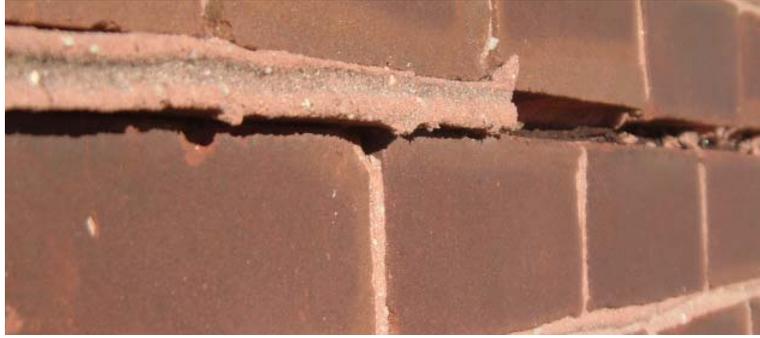
4. Cracked terrazzo finish and slab settlement are visible in the lobby adjacent to the cafeteria. Again, poorly compacted soil around the basement walls is the most probable cause. In addition, cracks in the terrazzo exist in the framed corridor over the below grade mechanical tunnel. An investigation of this basement area revealed only minor surface rusting in the metal deck. It is CEI's opinion that the underlying structure is stable, and that the cracking in the terrazzo finish is not indicative of a structural weakness.
