Scope Study Update

HOMESTEAD/WAKEFIELD ELEMENTARY SCHOOL

HARFORD COUNTY PUBLIC SCHOOLS
February 22, 2021

BANTA CAMPBELL ARCHITECTS, INC.

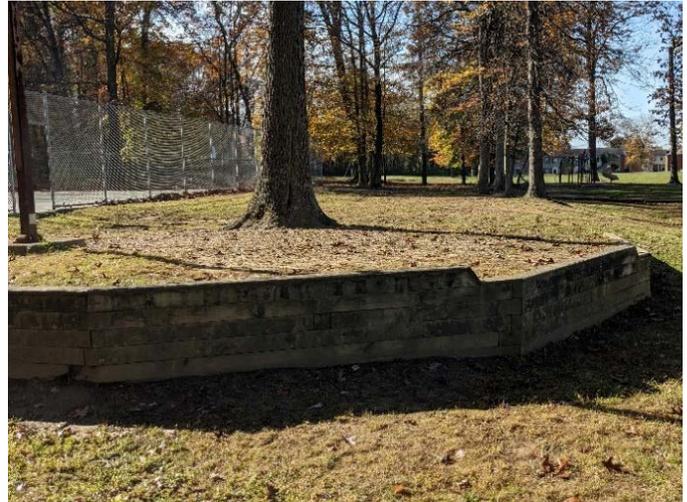
Timber Site Wall

There is a masonry site wall located near the loading dock area of the Wakefield school. This wall is in fair condition, however, there is some minor cracking that will likely require maintenance or replacement. There is also a timber site wall located between the hard surface play courts and the southeast side of the Homestead building. This wall is also in fair condition and may require maintenance or replacement.

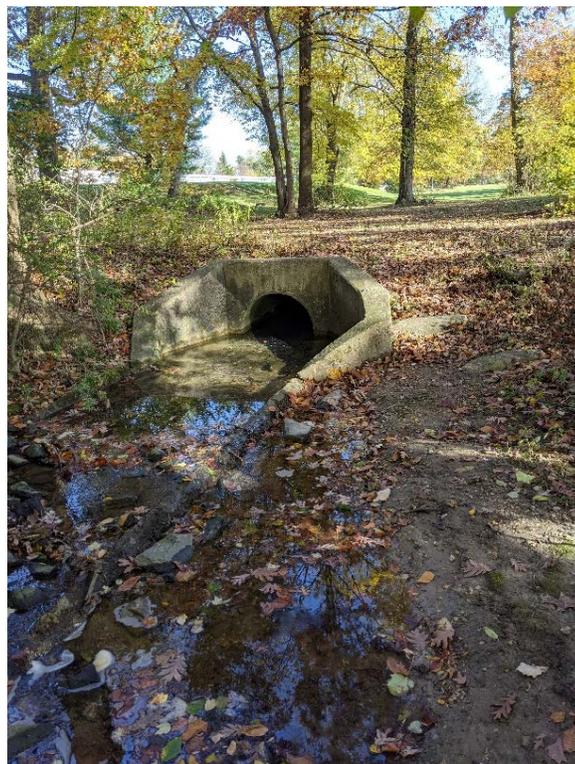
End Wall Outfall into Plumtree Run

There is no 100-year floodplain on site delineated on FEMA FIRM map 24025C0163E or FEMA FIRM map 24025C0164E. An existing ephemeral stream on the northern most corner of the site collects drainage from neighboring properties. The onsite storm drainage system then conveys that water along with the site drainage to a perennial stream located on the western side of the site. This stream eventually flows into the main branch of Plumtree Run off-site. Additionally, the on-site athletic fields and courts behind Homestead Elementary drain overland to this perennial stream into Plumtree Run.

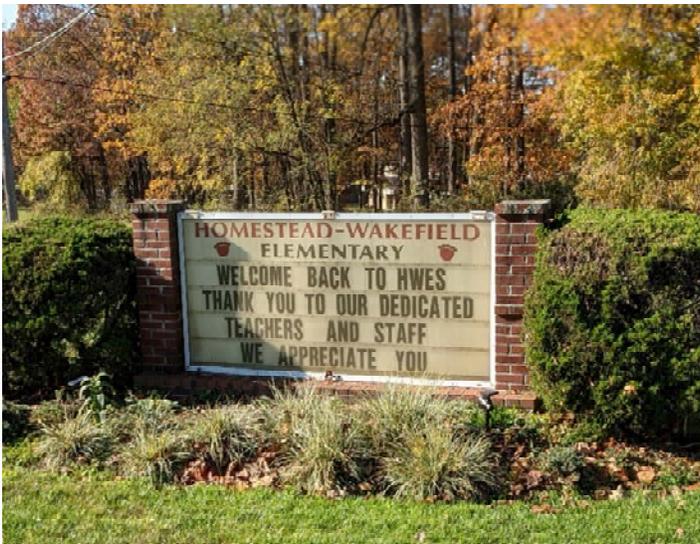
Main Entrance Signage

A large masonry monument sign is provided at the main vehicular entrance to both schools. Signage directs vehicular traffic to the designated bus and parent drop-off driveway loop at the Wakefield School. There are various parking signs designating specific times of day where parking is not permitted. There are several signs throughout the site that prohibit skateboarding and roller blading on the school property. A large sign is provided directing vehicular traffic to the locations of the Wakefield Building, the Homestead Building, and Bel Air Middle School. Some of the existing signage may require replacement due to poor condition. In addition to maintaining or replacing the existing site signage, additional signage will be required to designate handicapped accessible routes to the building and related facilities.

The existing masonry monument sign adjacent to the main vehicular entrance may remain, however, site design and construction may require its replacement. Updated and relocated signage will be required to direct vehicular traffic to the designated bus and parent drop-off areas. Signage will also be required to prohibit skateboarding and roller blading on the school premise. Additional signage will be required to designate handicapped accessible routes to the building and related facilities. Opportunities for outdoor classroom and SWM facility educational signage will be explored during the design process.
