William Paca / Old Post Road Elementary School

## Scope Study

July 6, 2009

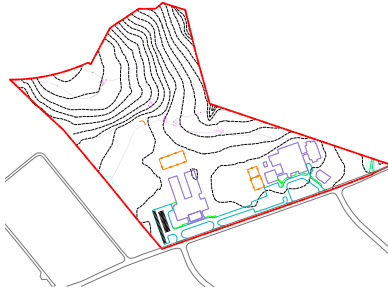
Site Fig. E

The school property (Site Fig. E) is currently zoned R1, Urban Residential. The property is bounded on the west side by business zoned land, B2, and by residential zoned land, R2. To the north the property is bounded by commercial/industrial zoned land, CI. To the east the property is bounded by residential zoned land, R1.
